Manhole Inspection Summary

Manhole # S15CC_005MH

Insp Date: **5/13/09 9:54 AM**

Location Address: **2527 RIGGS AVE**

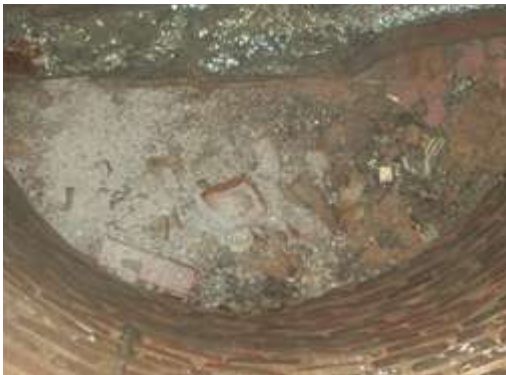
Defect 4

Condition: ☐ Sound ☐ Cracked ☐ Root Intrusion ☒ **Deteriorated** ☐ Leaks ☐ Debris

DETERIATED BENCH

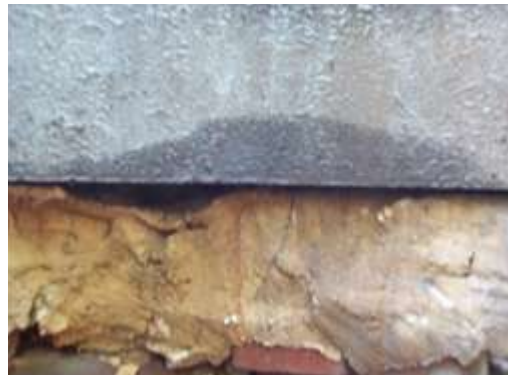
Defect 3

Condition: ☐ Sound ☒ **Cracked** ☐ Root Intrusion ☐ Loose Brick ☐ Deteriorated

CRACKED CHIMNEY

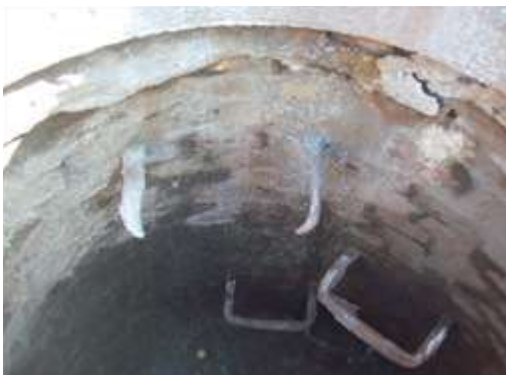
Defect 2

Count: **4** Missing: **1** ☒ **Corroded**

CORRODED STEPS

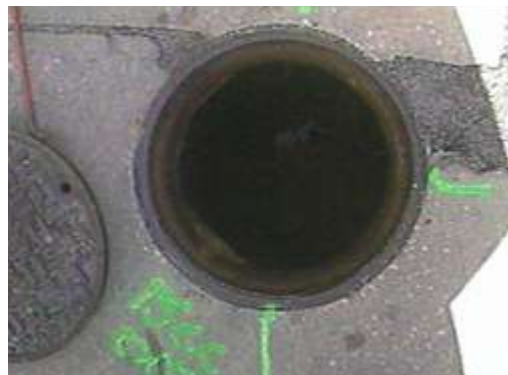
Defect 1

Offset: **2** (in.)

FRAME OFFSET

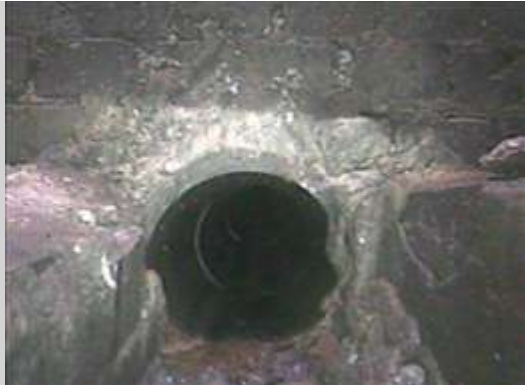
12 O'Clock Outflow

8 in. Circular Gravity Sewer
Pipe Out @ 12 O'Clock

Pipe Material: **Clay** ☐ Pipe Lined

Invert Depth: **8.15** (ft.) Flow Characteristics: **Fast**

Infiltration: **None** Pipe Seal Cond: **Sound**

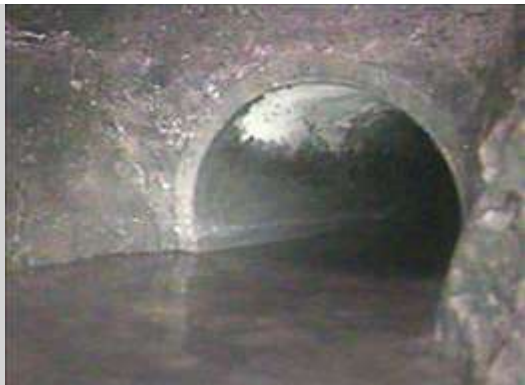
3 O'Clock Inflow

8 in. Circular Gravity Sewer
Pipe In @ 3 O'Clock

Pipe Material: **Clay** ☐ Pipe Lined

Invert Depth: **8.24** (ft.) Flow Characteristics: **Slow**

Infiltration: **None** Pipe Seal Cond: **Sound**

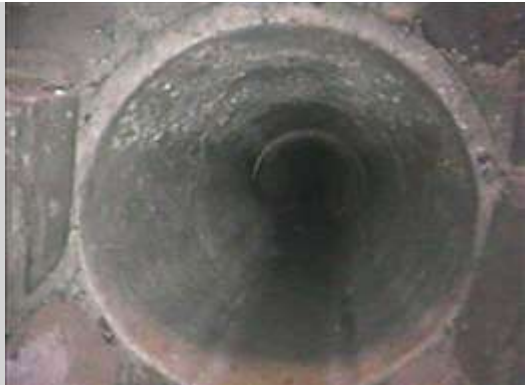
6 O'Clock Inflow

8 in. Circular Gravity Sewer

Pipe In @ 6 O'Clock

Pipe Material: **Clay** ☐ Pipe Lined

Invert Depth: **8.18** (ft.) Flow Characteristics: **Fast**

Infiltration: **None** Pipe Seal Cond: **Sound**
